# Manhole Inspection Summary

Manhole # S13II\_046MH

Insp Date: **2/24/09 11:16 AM**

**Location** Address: **REAR 2918 NORTH AVE**

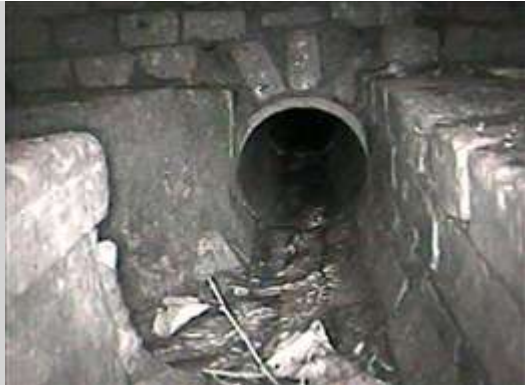
12 O'Clock Outflow

8 in. Circular Gravity Sewer  
Pipe Out @ 12 O'Clock

Pipe Material: **Clay** ☐ Pipe Lined

Invert Depth: **8.12** (ft.) Flow Characteristics: **Slow**

Infiltration: **None** Pipe Seal Cond: **Sound**

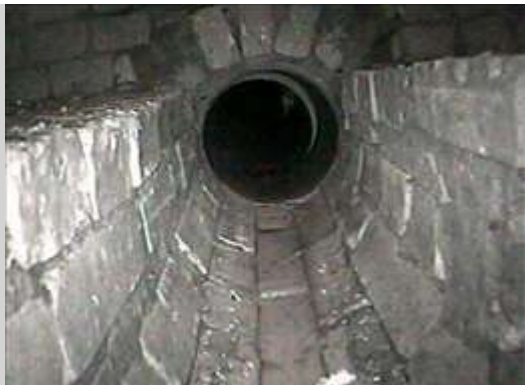
6 O'Clock Inflow

8 in. Circular Gravity Sewer  
Pipe In @ 6 O'Clock

Pipe Material: **Clay** ☐ Pipe Lined

Infiltration: **None** Pipe Seal Cond: **Sound**
